SUBJECT: Site Inspection, Bedrock Stone, Bacon Rock Quarry, S/037/101, San Juan County, Utah

Date of Inspection: March 19, 2004
Time of Inspection: About 10:05-10:15 a.m.
Conditions: Mostly clear, 60's
Participants: Paul Baker, DOGM

S/037/101, Bacon Rock Quarry, Bedrock Stone

Inspection Dated: March 19, 2004; Report Dated: April 21, 2004

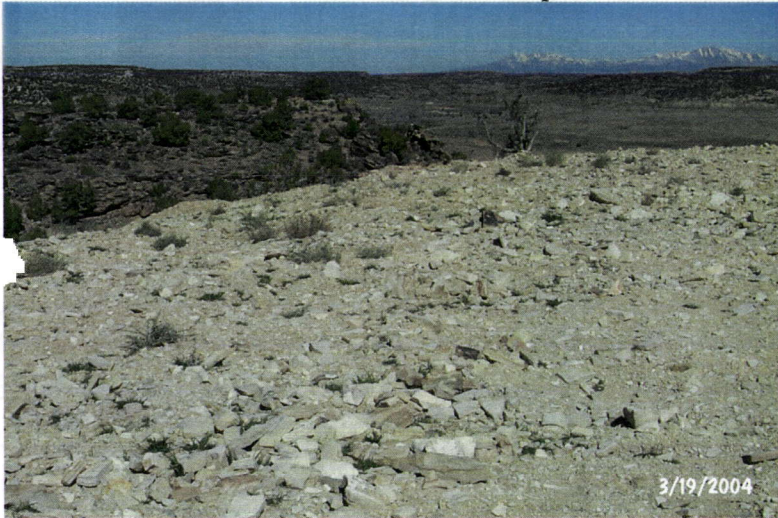
Photo 1. Note the amount of rock on the surface. This area is unlikely to have erosion problems.

This site was reclaimed in 2003, but the Division did not release it because there was not yet adequate vegetation and because three growing seasons had not elapsed since the last seeding. The site has been well contoured and has a lot of rock on the surface. There are no erosion problems nor do I anticipate any.

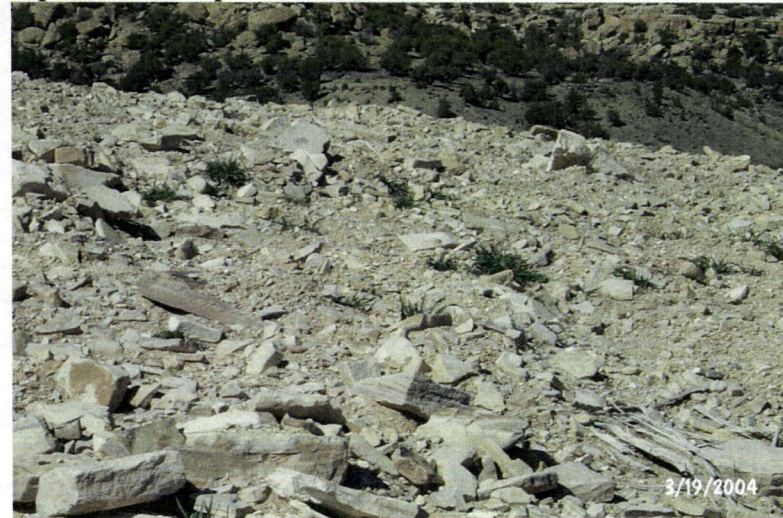
Photo 3.

The site is shown on Photos 1, 2, and 3. These pictures do not show much vegetation, but there are a lot of small seedlings that do not show up well in the pictures. Vegetation is spotty but progressing. With two more seasons of reasonable precipitation, I anticipate it will be possible to release the site in the fall of 2005.

No remedial action is necessary. The Division and the operator just need to wait for the vegetation to progress to where the site meets release criteria.

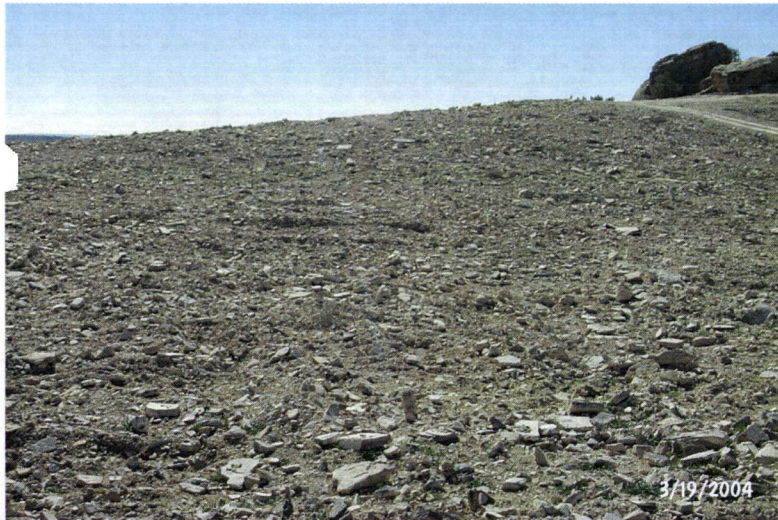
Photo 2. There is quite a bit more vegetation than is visible in this photo.
